**INDIAN ROADS CONGRESS
2007**

**GUIDELINES
FOR REPAIR AND REHABILITATION
OF STEEL BRIDGES**

IRC : SP : 74-2007

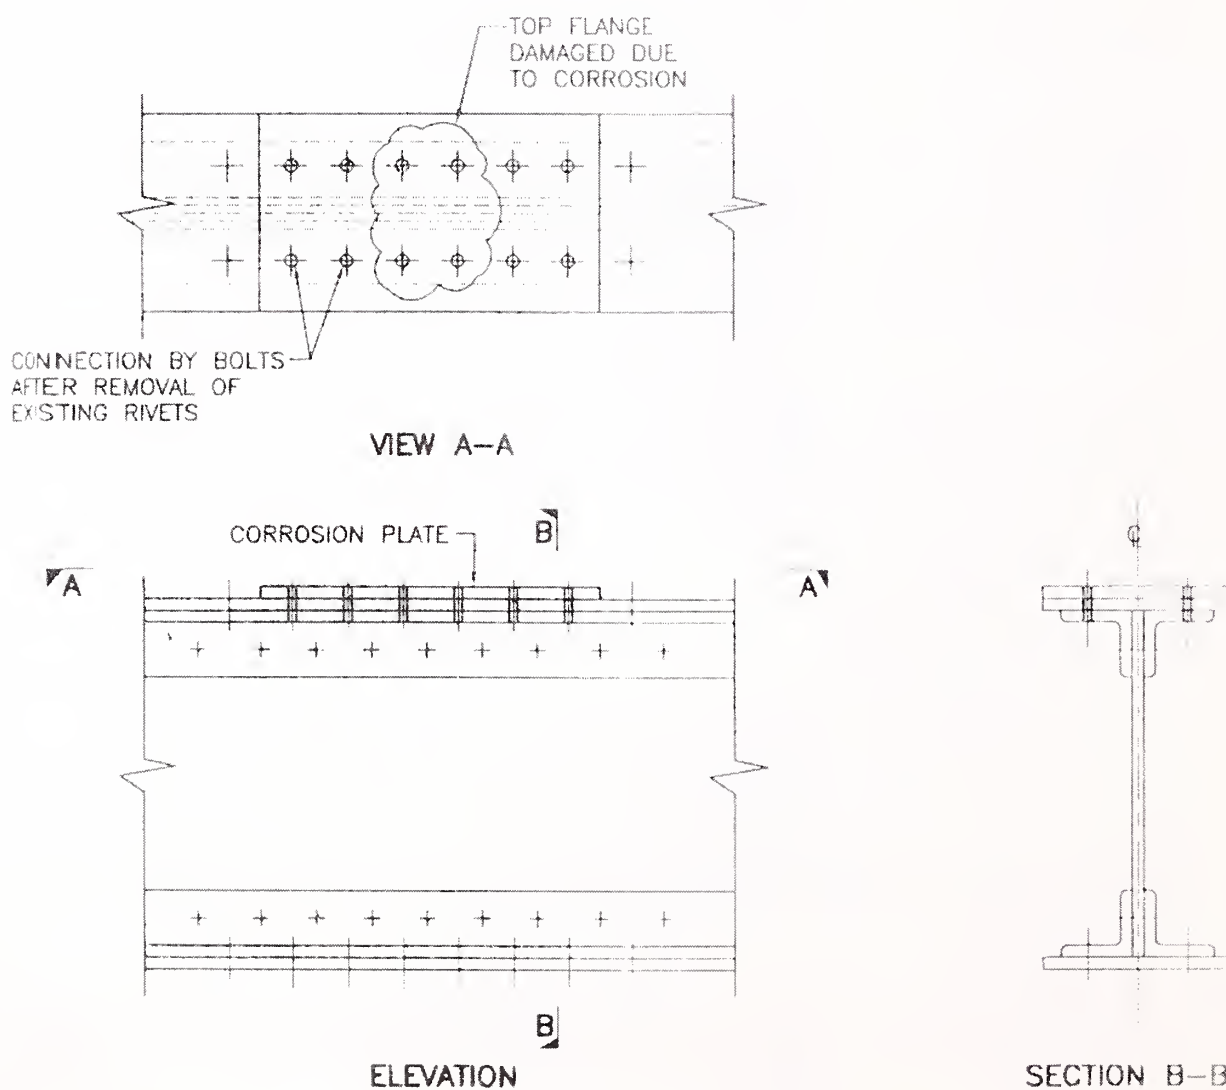
Fig. 1: Rehabilitation of corrosion damaged top flange plate of a riveted girder

(a) When top flange of a beam or girder is damaged due to corrosion, a steel plate of adequate size is provided over the top flange and secured to top flange by bolts, using the holes of the existing rivets after reaming as necessary. Use of high strength turned and fitted bolts are generally preferred over other types of bolts, since these bolts can be made to fit tightly (slip free) to match the existing rivet holes and thus their behaviour pattern becomes somewhat identical to that of the other adjoining existing rivets. This ensures satisfactory transmission of forces to the additional material.

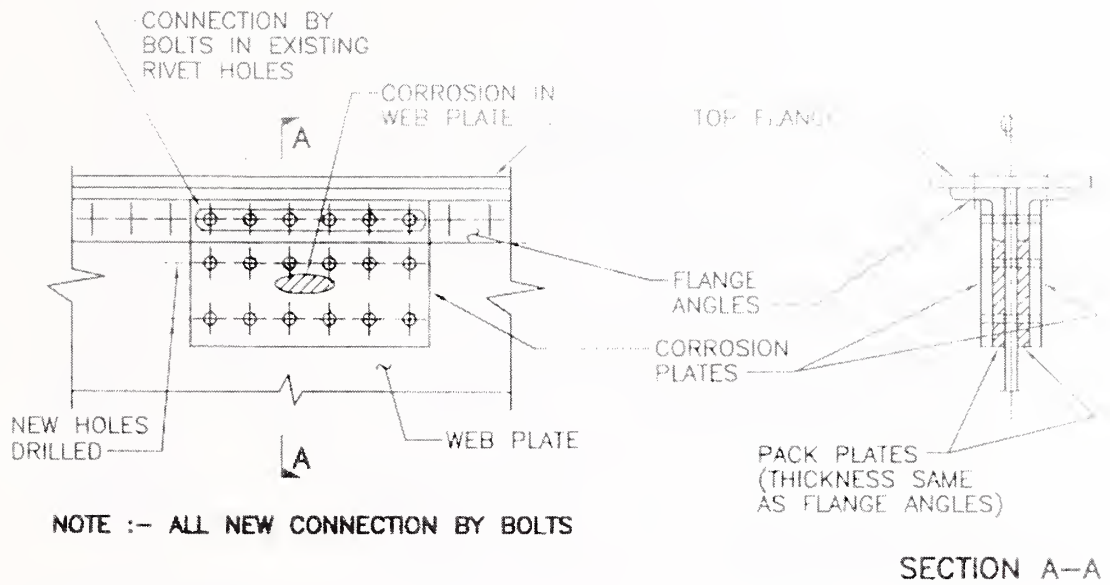
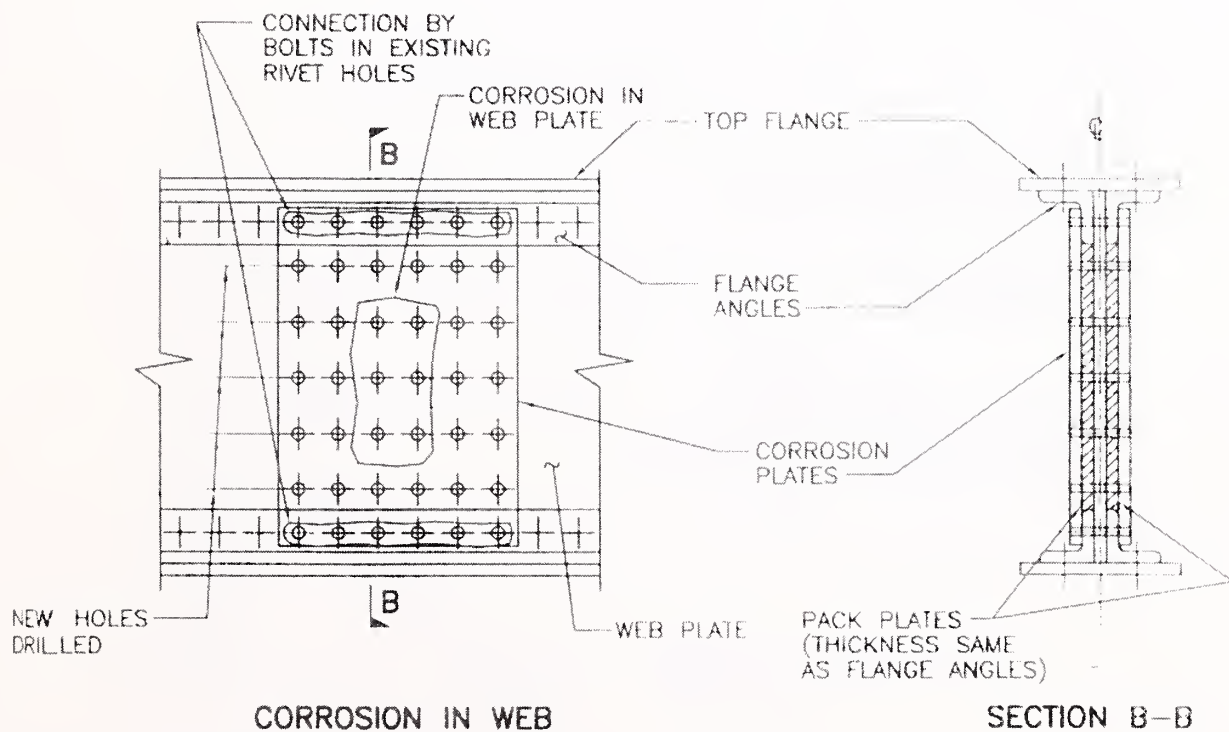
Fig. 2: Rehabilitation of corrosion damaged web plate of riveted girders

(b) Web plates of a beam or girder damaged due to corrosion can be repaired by fixing corrosion plates of adequate size, preferably on both sides of the web and securing these by high strength turned and fitted bolts. The details of the arrangement will depend on the location, extent and degree of the damage.

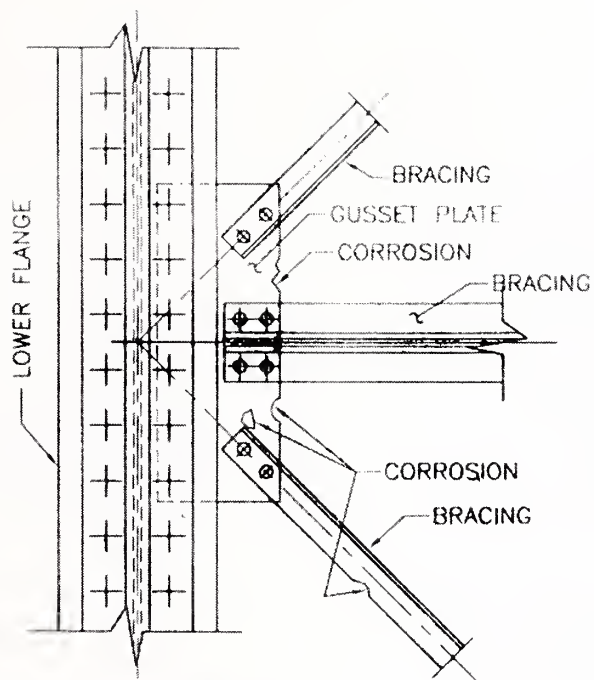
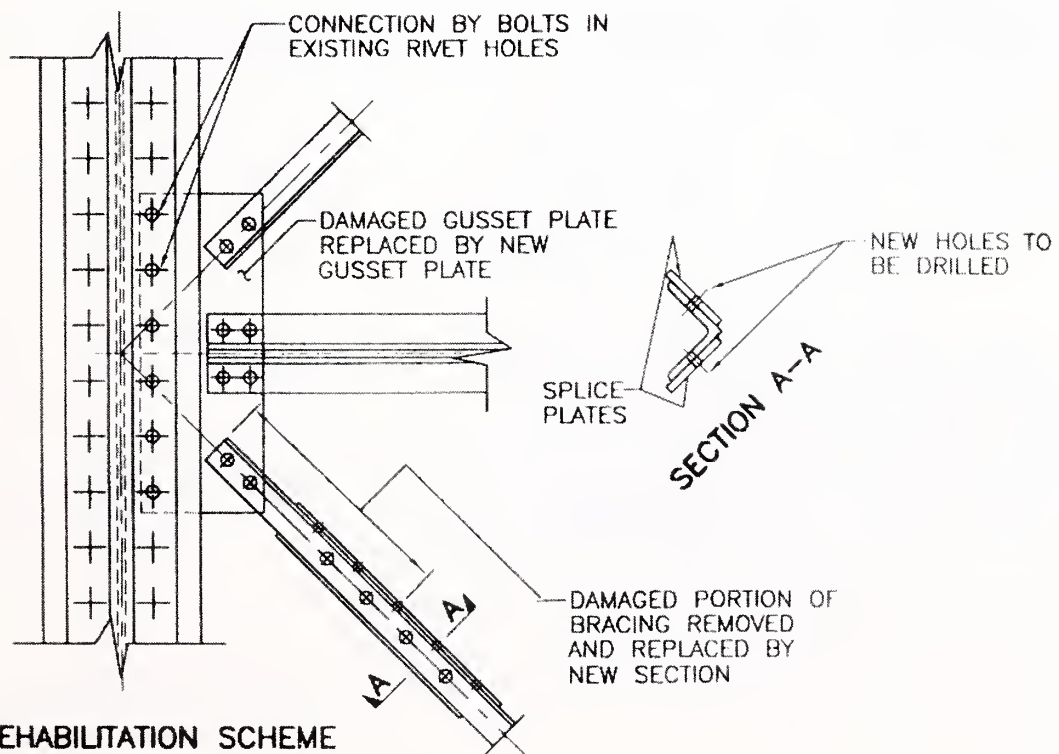
(a) EXISTING DETAIL

(a) REHABILITATION SCHEME

Fig. 4: Rehabilitation of corrosion damaged lateral bracings

(c) Corroded secondary members, such as lateral bracings, can be repaired by fixing corrosion plates on the bracing angles at the location of damage by means of bolts. However, when a bracing member is badly corroded at a number of locations, it is preferable to replace the member rather than repair it.

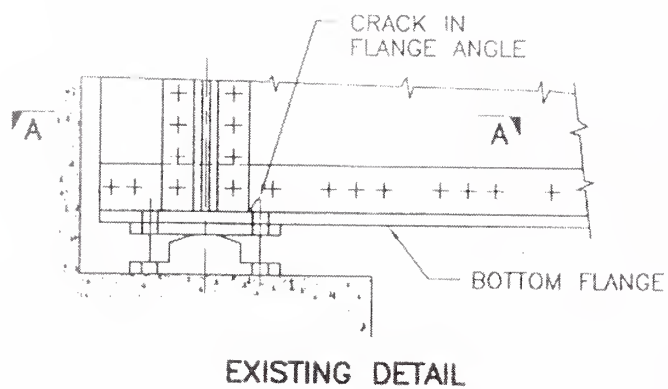
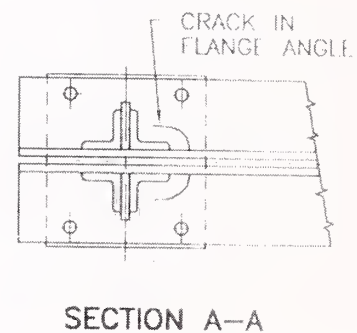
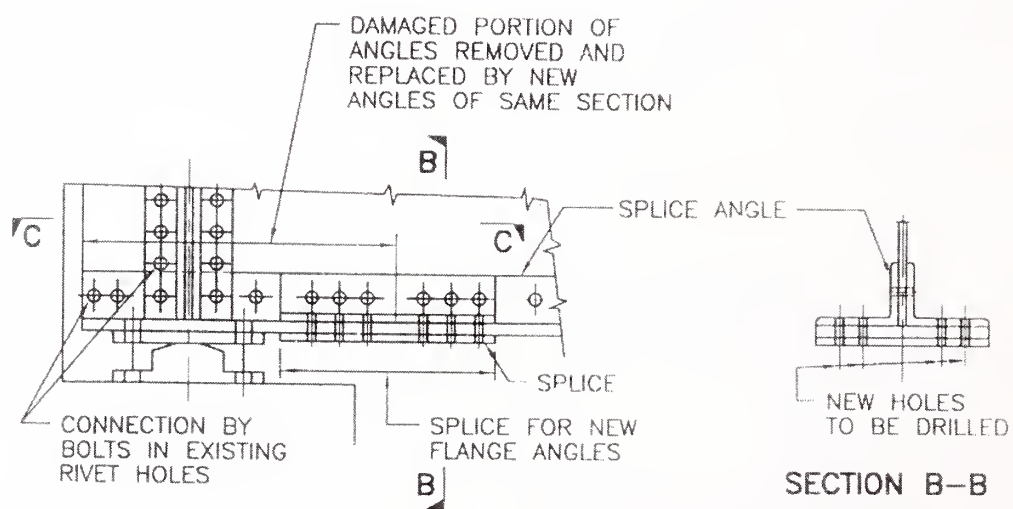
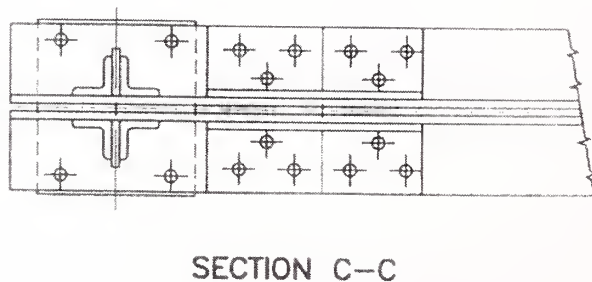
Fig. 5: Retrofit for crack near support in bottom flange angles of a riveted girder

Cracks occurring in isolated locations can be repaired by drilling a hole of 13.5 to 23.5mm diameter at about 20mm beyond the

tip of the crack, along its assumed line of further progress, to arrest the crack propagation. This will generally be a temporary repair and should be followed by fixing splice plates or splice angles with adequate number of bolts on either side of the crack. This is a very common solution for isolated cases of cracks. For multiple cracks in a single member it may be desirable to replace the cracked member by an identical member. Alternatively only the portion of the member, which has been damaged, may be replaced and an adequate splice connection between the new part and the existing part may be provided.

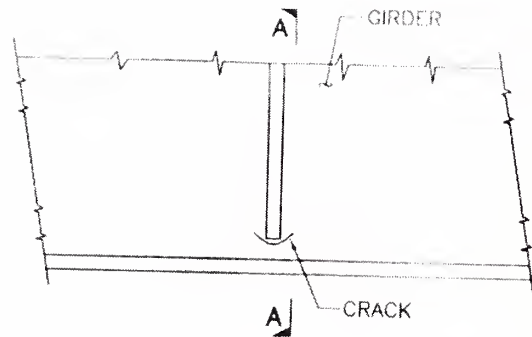
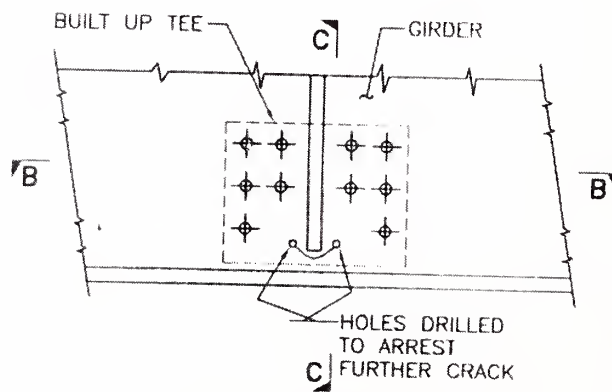
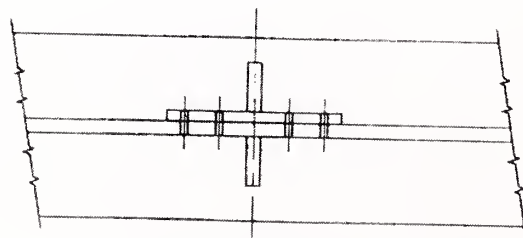
(a) TYPICAL CRACK AT LOWER END OF WELDED STIFFENER

(b) PROPOSED RETROFIT

SECTION B-B

Fig. 7: Rehabilitation of crack in web of welded girder

In welded girders, typical cracks may occur in the web near the lower end of the welded stiffener connection to the web. These cracks can be repaired by drilling holes beyond the tips of the crack and then gouging out the cracked portion and depositing weld metal in its place, followed by removing the excess metal by grinding. However, for undertaking field welding, the chemical composition of steel should be ascertained and appropriate electrode should be chosen in consultation with experts. A suitable, bolted splice on the other face of the web would provide added strength.
